**Collision With Trees on Final Approach
Federal Express Flight 1478
Boeing 727-232, N497FE
Tallahassee, Florida
July 26, 2002**

Aircraft Accident Report

NTSB/AAR-04/02

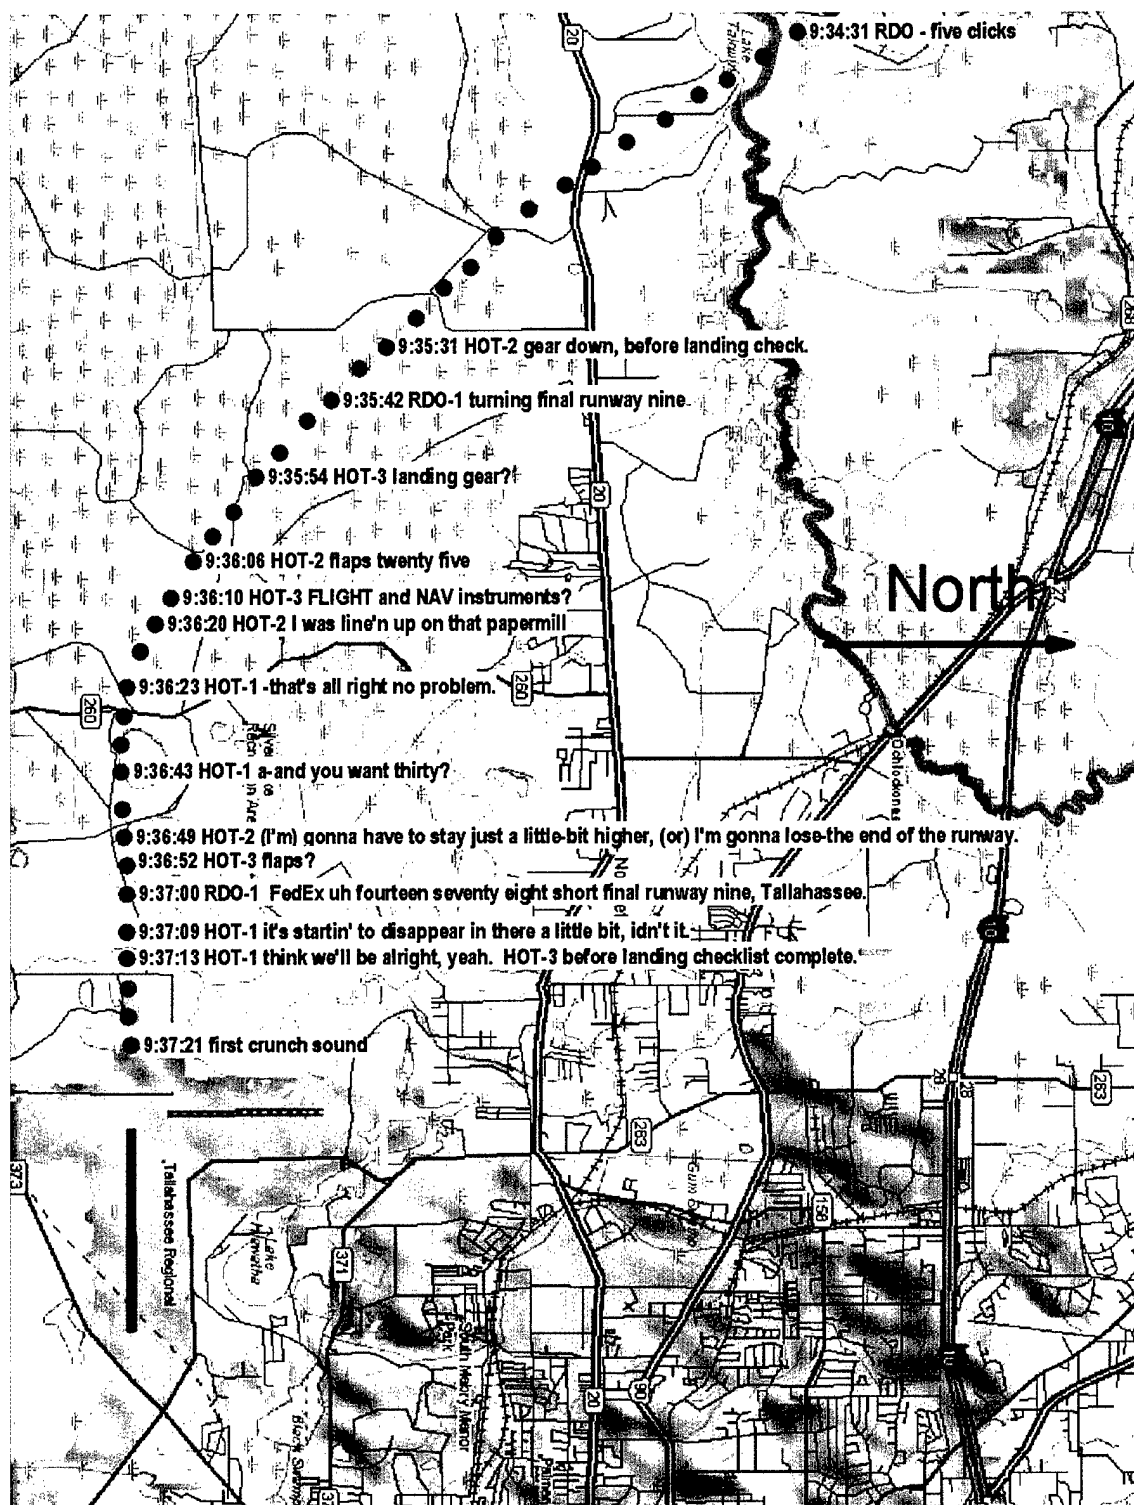
Figure 3. A map overlay of FedEx flight 1478's radar track into runway 9 at TLH, with excerpted CVR comments.

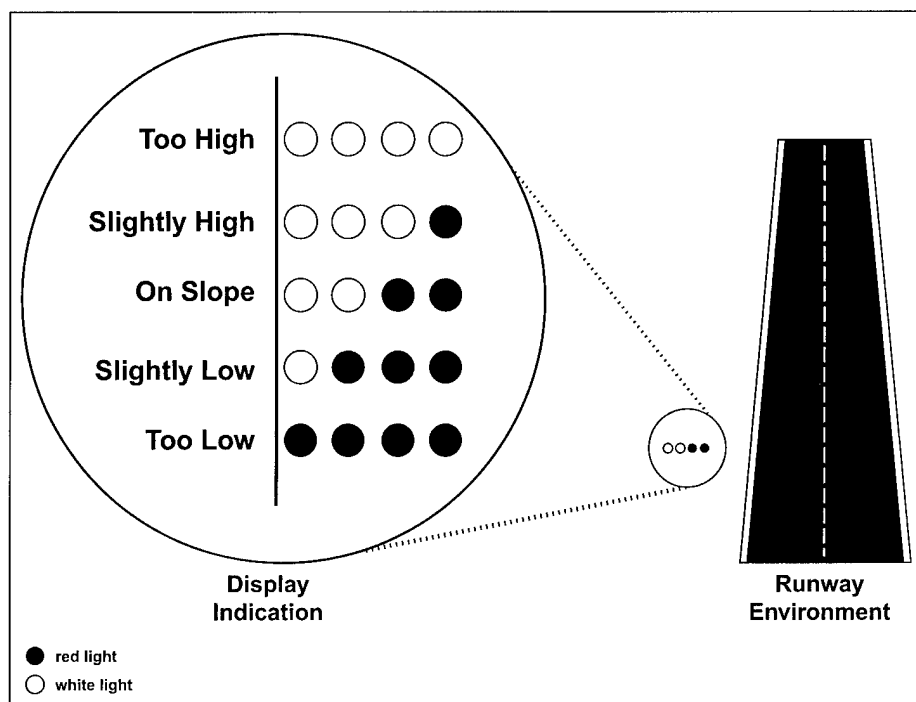
Figure 6. PAPI indications from various approach path angles.
